Denickelification and Dezincification of Copper Alloys in Water Environments

Jun-Fu Liu, Mel J. Esmacher and David Kotwica

GE Power & Water, Water & Process Technologies, 9669 Grogans Mill Road, The Woodlands, TX 77380

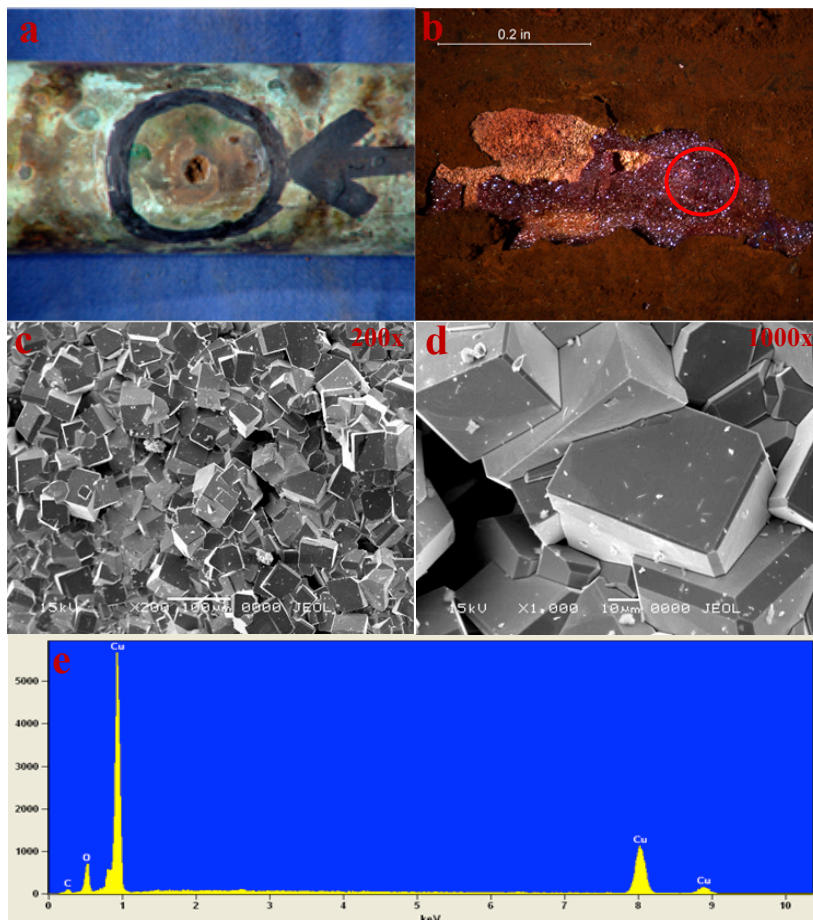
Case 1 (Figure 1a) is a failed copper-nickel tube section (10% Ni, 1% Fe, 0.55% Mg, balance Cu) from a heat exchanger. City make-up water circulating on the tube side was heated by a hot gas stream on the shell side of the exchanger. The time in service was 20 years. Purple deposits are observed at some locations on the internal surface (Figure 1b). SEM images in Figure 1(c, d) and EDS analysis in Figure 1e show that the purple deposits consist of Cu micro-crystals.

Figure 1. Photographs of (a) Ni-Cu tube and (b) purple deposit on the inside surface, and SEM images (c, d) of Cu micro-crystals of the purple deposit, and (e) EDS result.

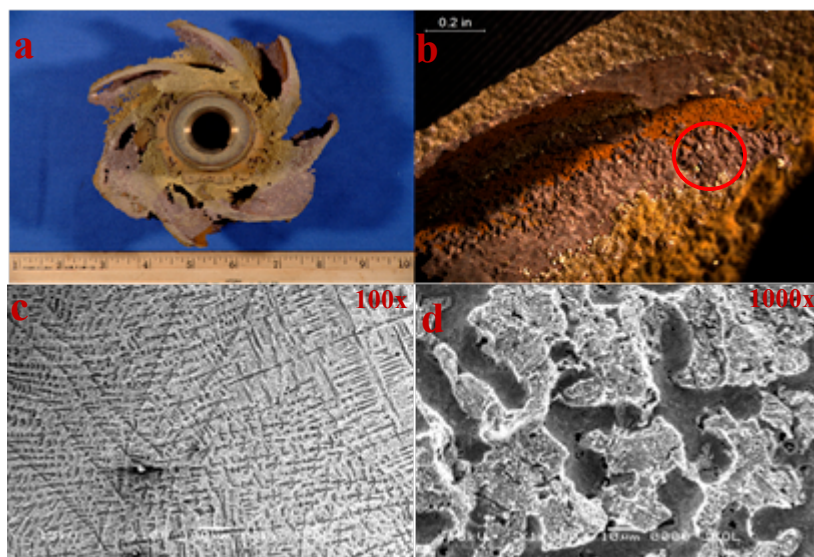
Case 2 (Figure 2a) is a silicon bronze pump impeller (7.3% Zn, 4.3% Si, balance Cu) from a booster pump. The time in service in potable water was 2 years. In addition to erosion corrosion (Figure 2a) due to excessive flow velocity and cavitation, surface dezincification of the bronze alloy resulted in localized red deposit area (Figure 2b). The SEM images in Figure 2(c, d) show that the area has a micro-porous surface texture. It is 99% Cu from the EDS analysis result.

Figure 2. Photographs of (a) a silicon bronze pump impeller and (b) red deposit on the inside surface, and SEM images (c, d) of red Cu deposit area.
