## The Role of Computed X-ray Tomography in a Metallurgical Analysis

Noah Budiansky, Joel Forman, and Ockert Van Der Schijff

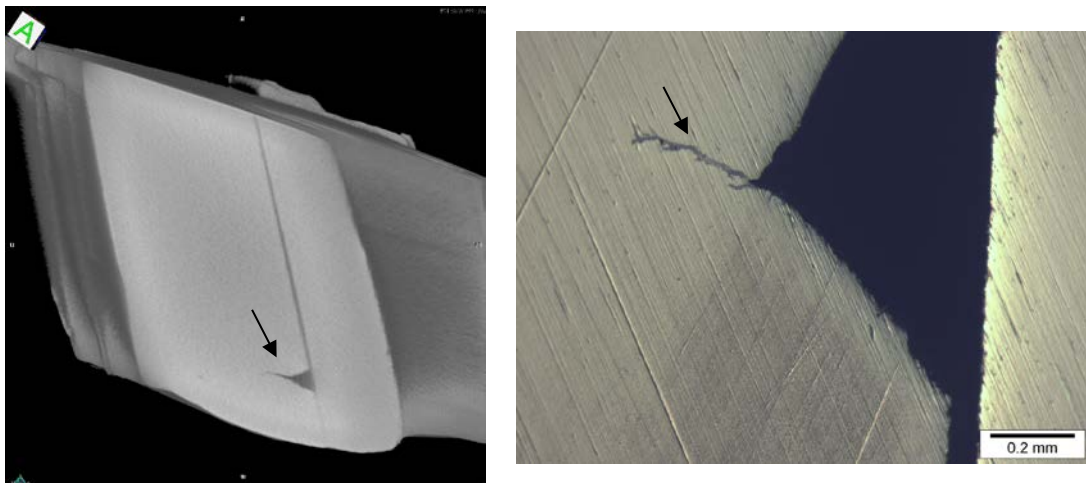
**Figure 2.** CT cross section through a three dimension projection and optical microscope image of a roughly polished cross section of a welded carbon steel heat exchanger tube/tube sheet. Arrows indicate the location of observed cracking.
