## Post-Irradiation Examinations of Irradiation Creep Tested Zircaloy-2

Wade Karlsen<sup>1</sup>, Mykola Ivanchenko<sup>1</sup>, Ulla Ehrnstén<sup>1</sup> and Ken R. Anderson<sup>2</sup>

<sup>1</sup> VTT Technical Research Centre, Espoo, Finland.

<sup>2</sup> Bechtel Marine Propulsion Corp., Bettis Laboratory, West Mifflin, PA, USA

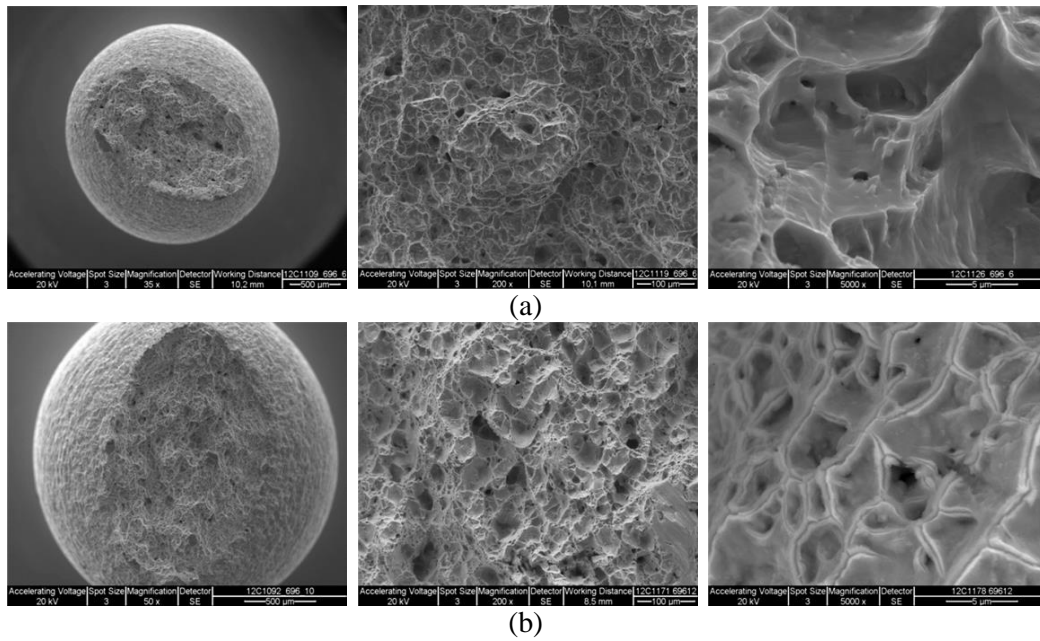
**Figure 1.** SEM fractography of two irradiation creep tested Zircaloy-2 specimens; (b) shows dimple walls exhibiting split fracture edges.

Scanning electron microscopy fractography was carried out using a Philips/FEI™ XL30 ESEM with a LaB<sub>6</sub> electron source. The fractured specimens showed asymmetrical necking, but the fractures were ductile and similar in appearance (Fig. 1). One of the specimens showed ductile dimple features, but with dimple walls exhibiting split fracture edges, rather than single, sharp edges (e.g., the higher magnification image in Fig. 1b). Dimensional measurements showed that in all cases there was significant localization of deformation, manifested by marked necking of the specimen, while the gauge diameter even 5 mm away from the fracture surface was still quite close to the specified original diameter.

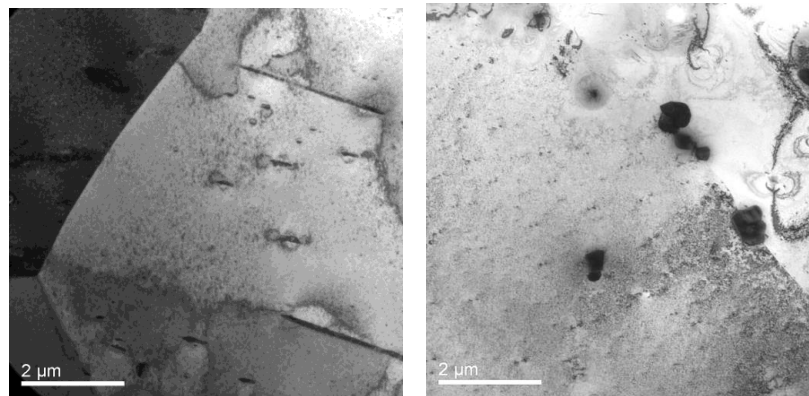
**Figure 2.** Low-magnification bright-field TEM images of irradiation-creep tested Zircaloy-2 – showing overall microstructures, including second-phase precipitates (mainly Zr-Fe-Cr Laves).

Bright-field TEM images of the general microstructure of irradiation-creep tested Zircaloy-2 specimens are shown in Fig. 2. Figure 3 shows higher-magnification bright-field TEM images of the primary irradiation-induced defects, <a>-type dislocation loops. The measured irradiation produced <a>-type dislocation loop populations were similar in all of the materials, with mean diameters ranging from 6 to 9 nm, and number density from  $1.8$  to  $2.9 \times 10^{22}/\text{m}^3$  (dislocation density  $4.5$  to  $7.3 \times 10^{14}/\text{m}^2$ ). Figure 3 also shows evidence of dislocation channeling. More details of the analysis will be given in the presentation. The results of this recent work presented here augment the work reported by Cockeram, *et al.* [1] and are directly related to and support the work reported by Kozar, *et al.* [2].

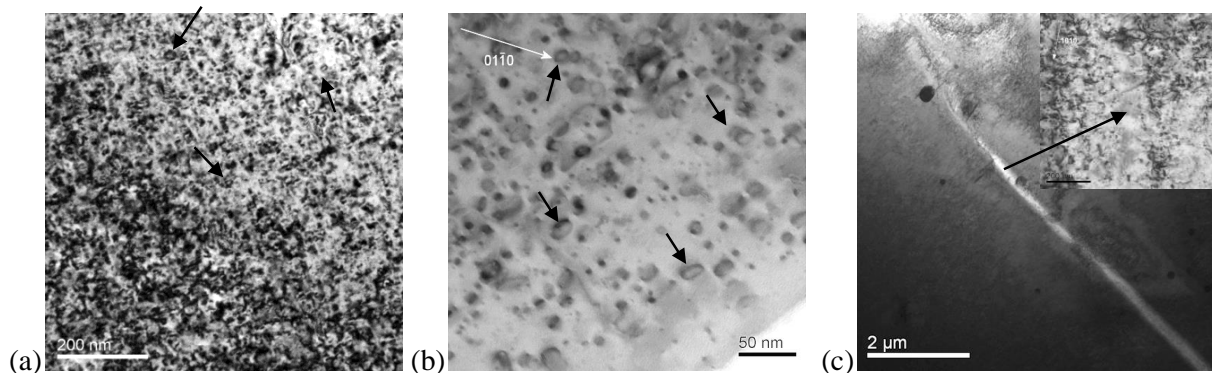
**Figure 3.** Higher-magnification bright-field TEM images of the primary irradiation-induced defects observed in the examined specimens:  $\langle a \rangle$ -type dislocation loops formed on prism planes of the hexagonal crystal structure, (a) and (b); and an example of a clear band indicating evidence of dislocation channeling in regions close to fracture surface of the deformed gauge region (c).
